Manhole Inspection Summary

Manhole # S41AA_065MH

Insp Date: 11/11/08 11:46 AM

Location Address: **1401 e monument st**

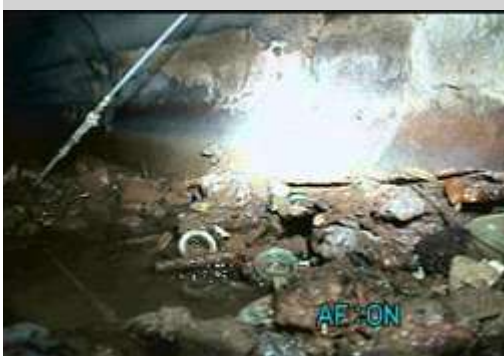
Defect 3

Condition: ☐ Sound ☐ Cracked ☐ Root Intrusion ☐ Deteriorated ☐ Leaks ☒ **Debris**

channel debris

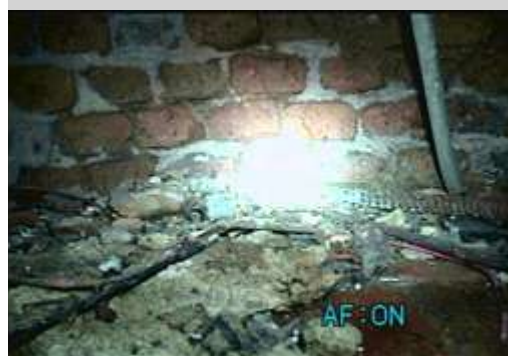
Defect 2

Condition: ☐ Sound ☐ Cracked ☐ Root Intrusion ☐ Deteriorated ☐ Leaks ☒ **Debris**

bench debris

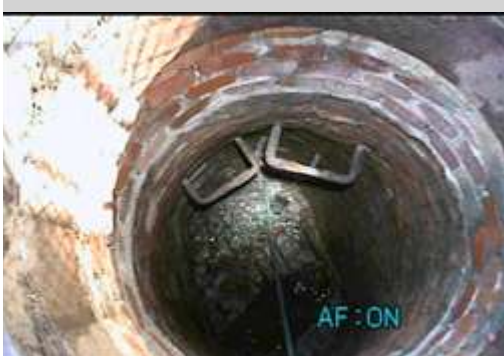
Defect 1

Count: **3** Missing: **0** ☒ **Corroded**

steps corroded
